# SPECIFIERS

## - specify to reduce maintenance costs!

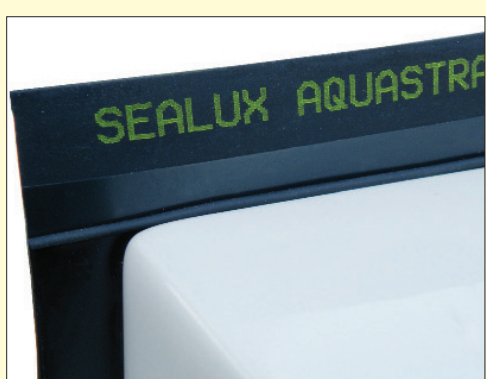
**Slimline shower trays are promoted without integrated up-stands in favor of more flexible retro-fit sealing solutions.**

**Polymeric up-stand seals are now available with pre-applied isolating membranes that protect the up-stand and butyl adhesive against reactive sealants in line with BS 6213 recommendations.**

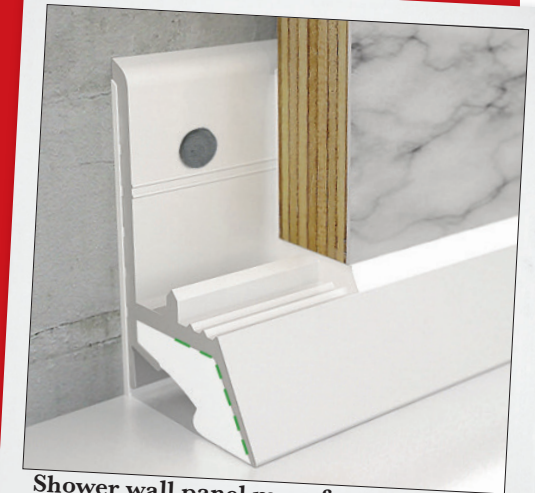
**Shower wall panel manufacturers have taken the initiative and offer a flexible durable movement joint seal that enhances performance and consumer satisfaction.**

Shower wall panel manufacturers have taken the initiative and include a flexible, durable sealant/trim combination seal in their product offering. The trim not only incorporates a sealant bond-breaker (greenline) to create a high degree of sealant flexibility but also acts as a shield that conceals the sealant from view and the deteriorating effects of the shower environment.

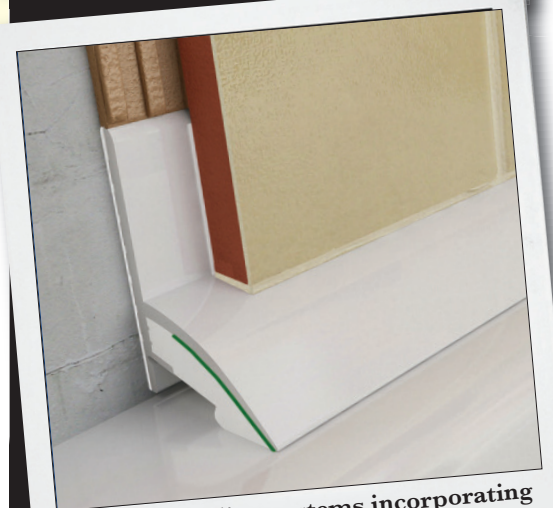
**Patented sealing systems incorporating pre-applied sealant bond-breakers are also available for installations with tiles.**
