The advantages of incorporating a Sealux Seal when waterproofing walls over trays & baths

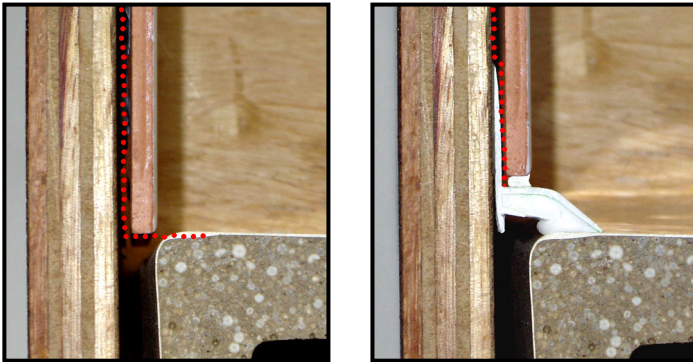
Problem: The membrane (red dotted line below) bonded to the ledge extends out beyond the outer face of the tile.

Solution: The installation of Sealux Reg 20 can bridge wall/ledge gaps up to 12mm. This makes waterproofing possible over all shower trays and baths.

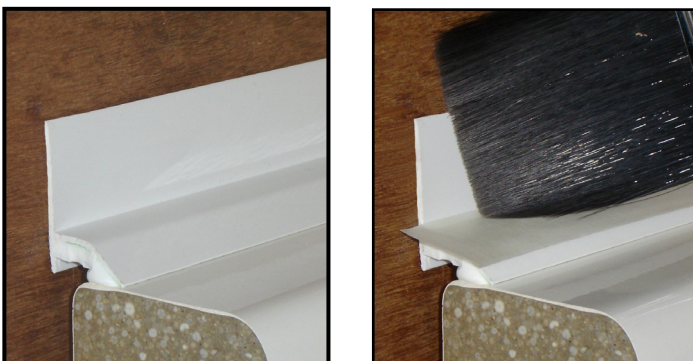
Problem: Bonding waterproofing membranes accurately onto the ledge can be an awkward precision task in a confined space that discourages installers because it absorbs time.

Solution: This task is made *easier and quicker* by first installing a Sealux Reg 20 profile over the joint, masking the strip and dressing the membrane down over the up-stand.
